U.S. ENVIRONMENTAL PROTECTION AGENCY POLLUTION/SITUATION REPORT 2015 Gold King Mine Release SITREP

Subject: SITREP #5

Gold King Mine Release

Date: 08/13/2015

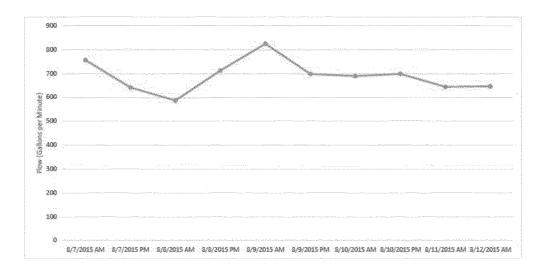
The EPA continues to operate four treatment and sedimentation ponds at the mine site which are treating water by lowering acidity levels and removing dissolved metals. Flow from the mine through the morning of 8/12/2015 is shown in the following chart. **As of 11 am on 8/13/2015**, there was no available updated water discharge data available.

Treated water from the last treatment pond is discharging into Cement Creek at levels cleaner (higher pH and lower levels of metals) than pre-event, background conditions in the creek. Flow data out of the mine is being collected manually two times per day. Water quality data is being collected at the influent and effluent of the treatment system as well.
